# Residual strength of mooring lines for weather buoys

Quantify mechanical property loss of hybrid polyester/polyolefin mooring lines in order to know their lifetime and study their potential reuse:

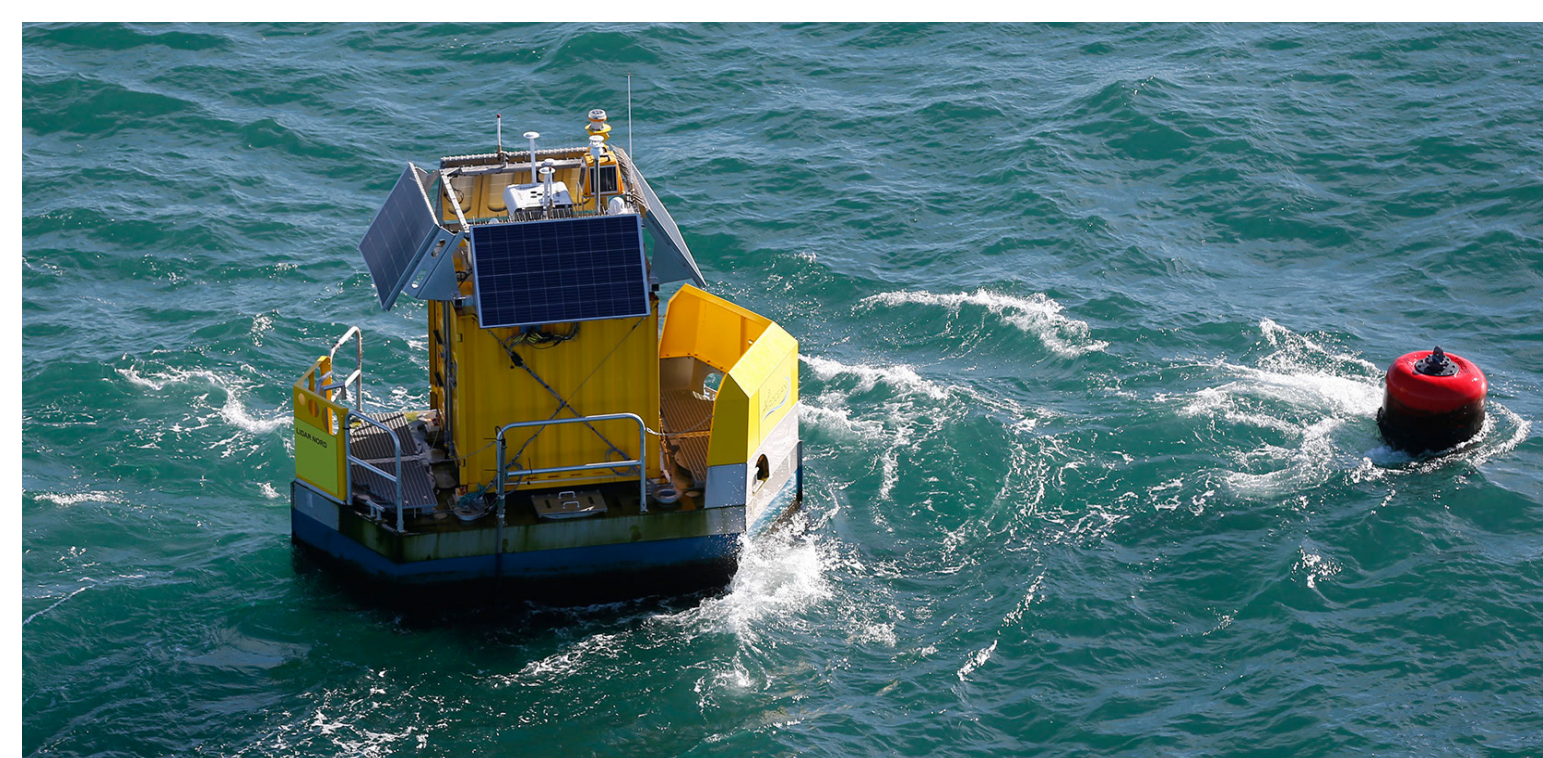
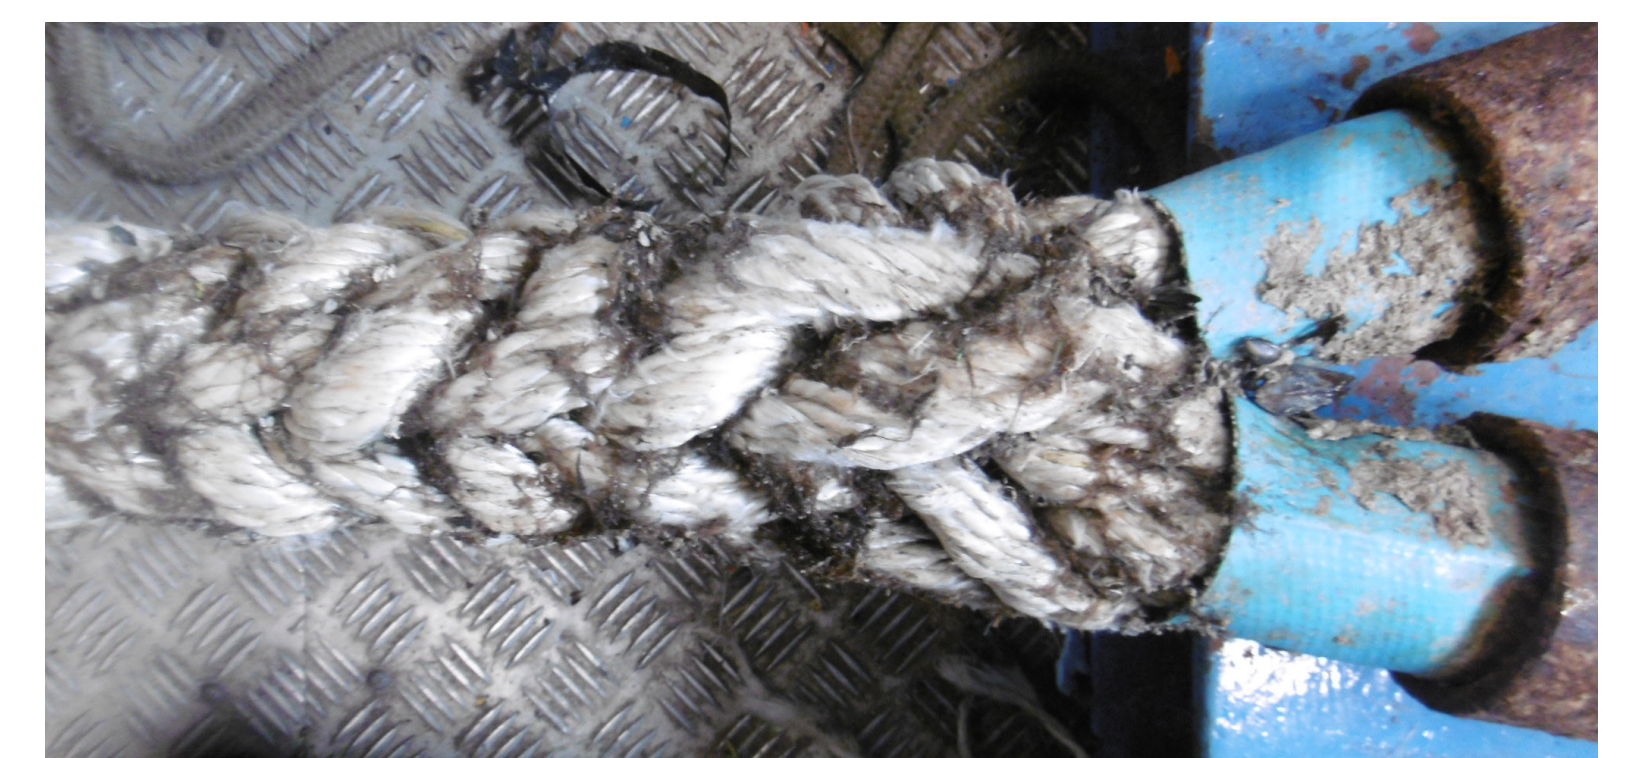
- | Mooring lines of weather buoys: Prepare wind farm installation, measure wind & waves.
- | Ropes with 8 strand braid, with 500kN of breaking load, polyester fibers around polyolefin fibers.
- | Ropes recovered after 1 to 2 year campaigns at sea.  
2 sites: Oleron & Irish Sea = 16 lines.

Mechanical loads + Marine environment

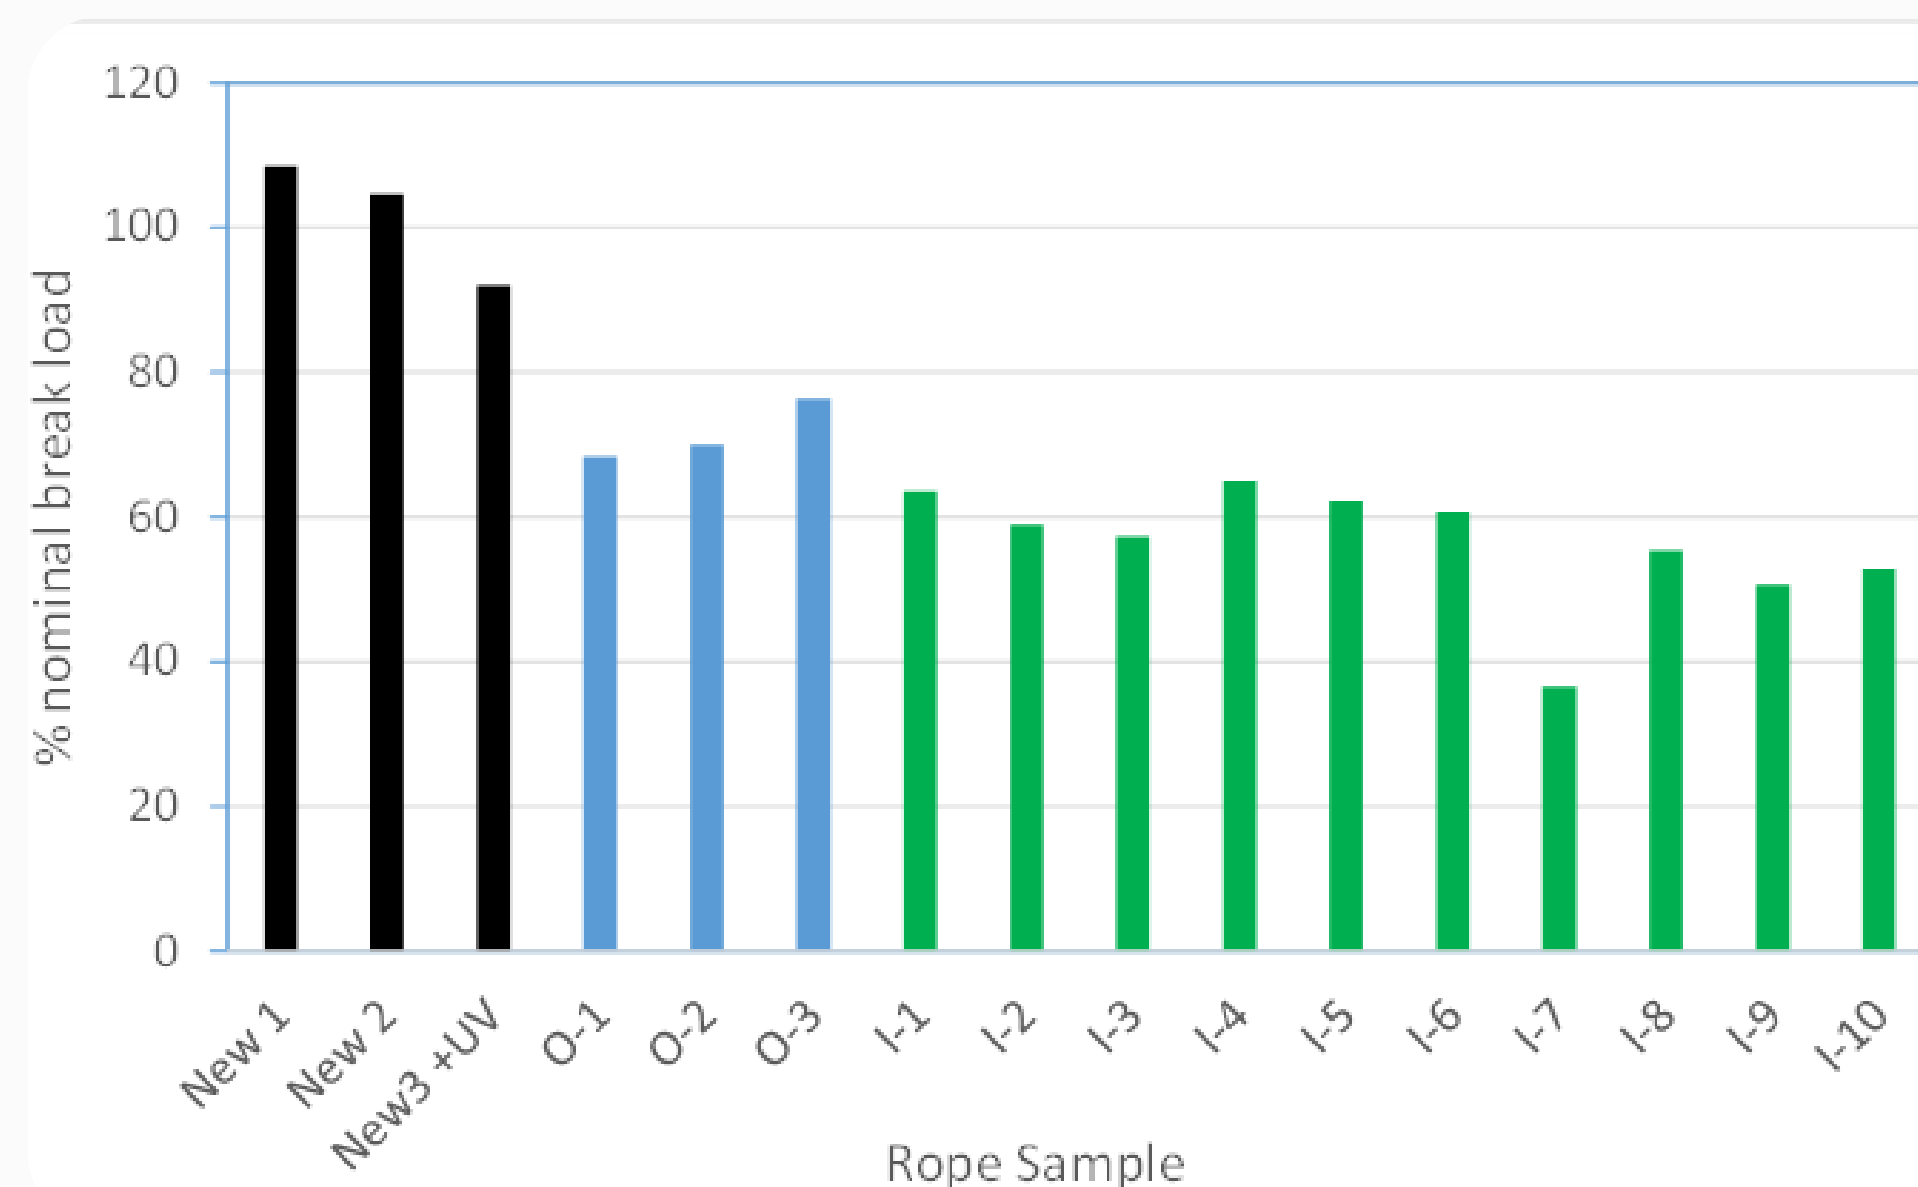
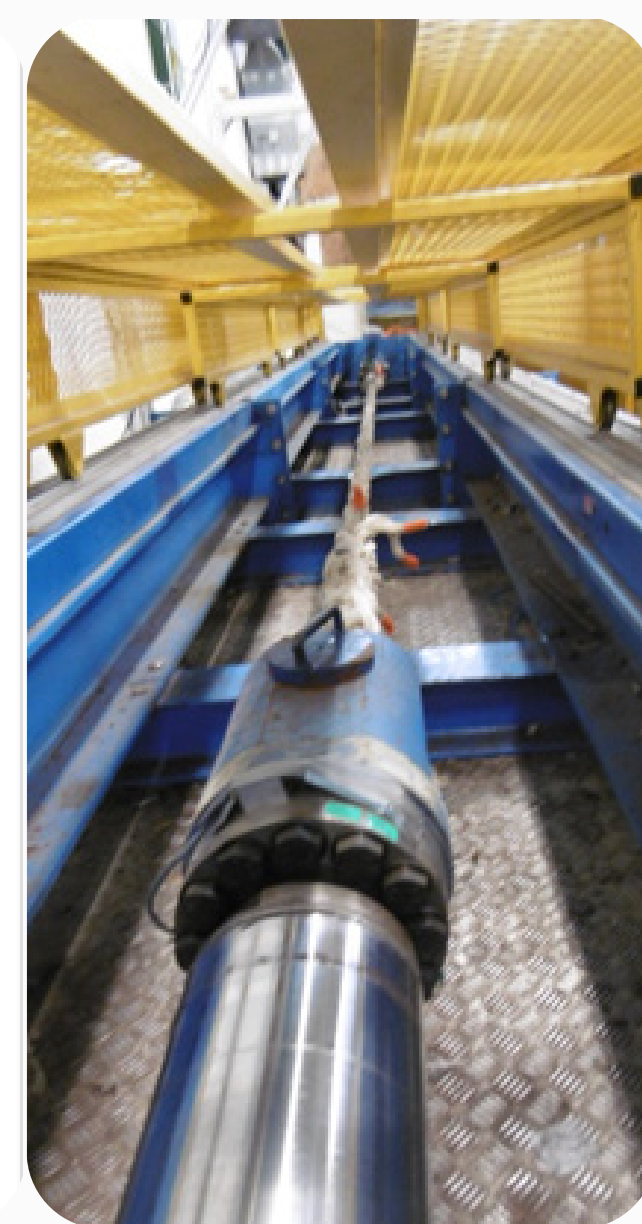
Full scale tests : ropes tested in tension to break on 1000kN test bench at Ifremer center, Brest  
**Large strength loss, up to 50%**

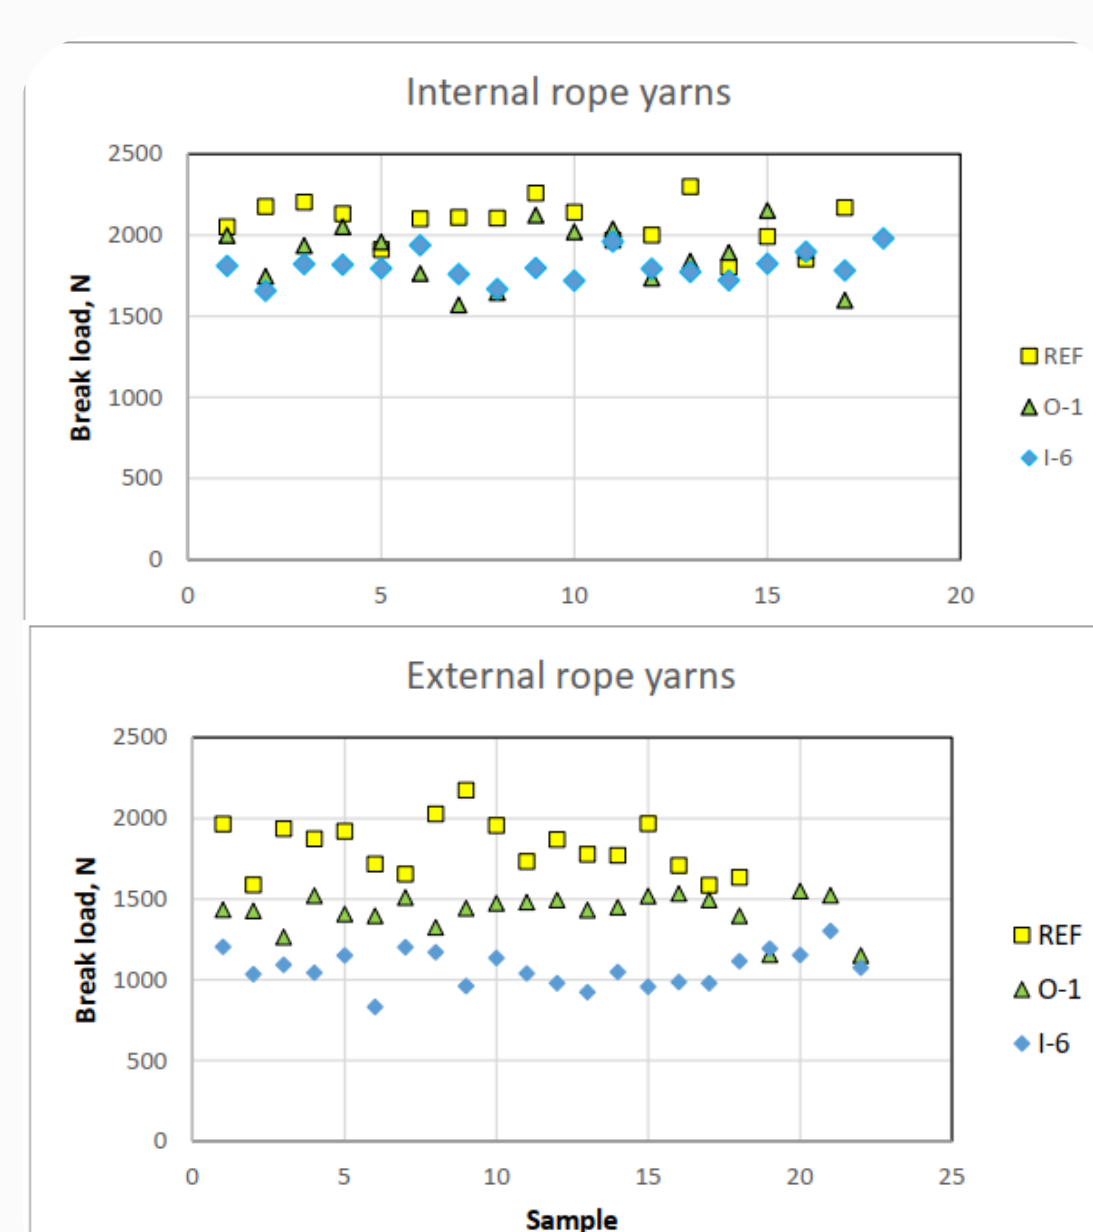
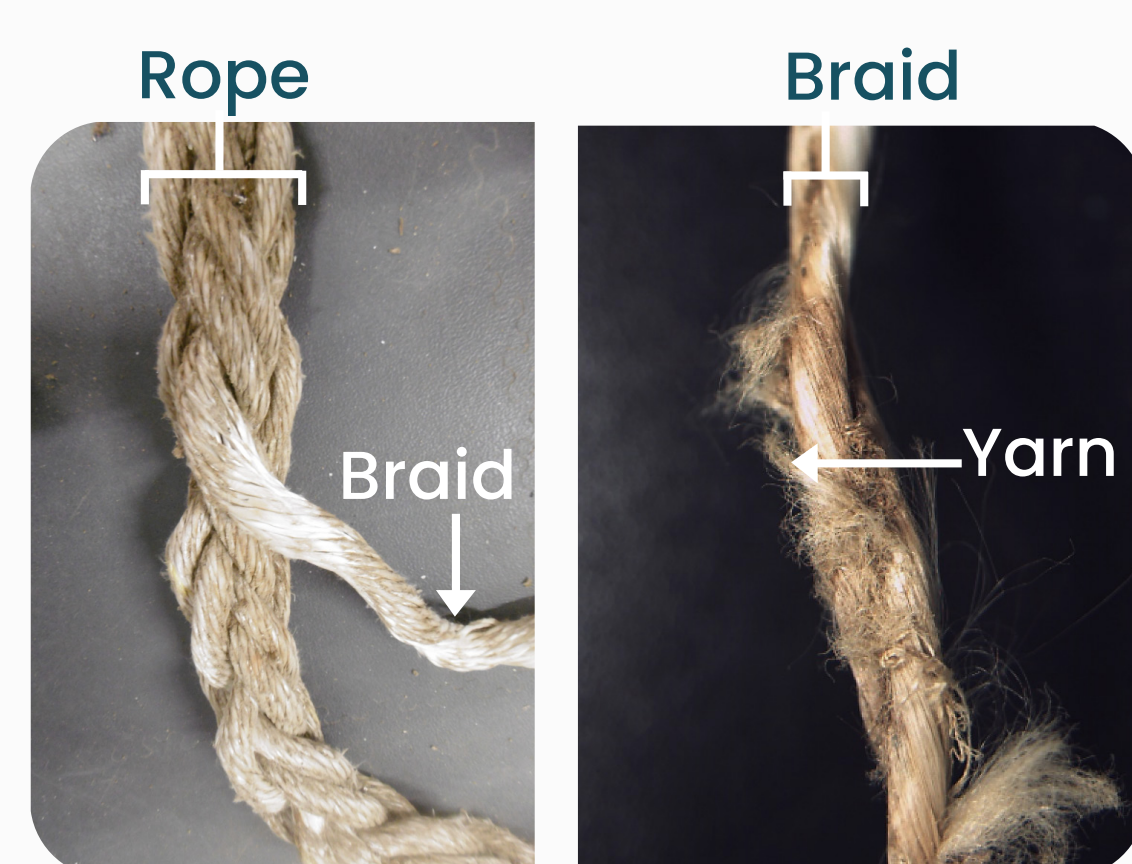
Yarns tested in tension to break on 10kN test bench  
**External degraded, not internal**

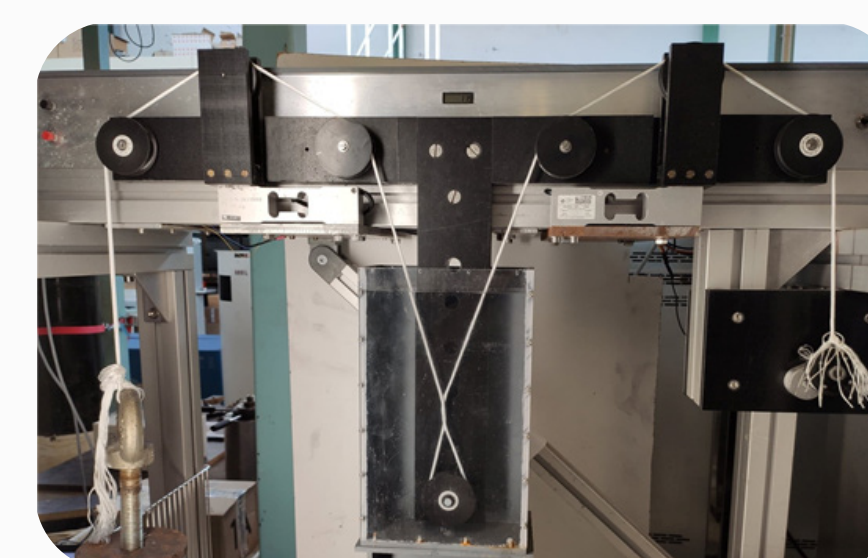
Calorimetry (DSC) : no evolution on polymer microstructure  
Abrasion : strong loss in Yarn on Yarn abrasion resistance for polyester fibers.

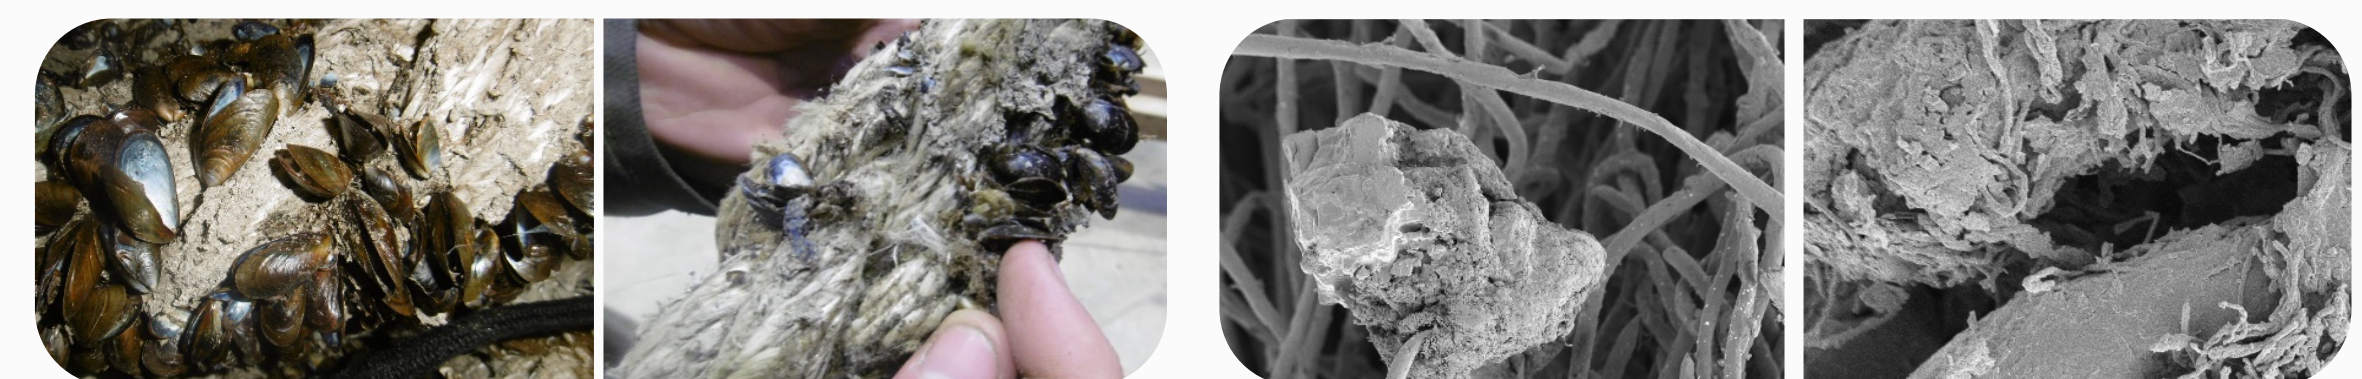
Optical and Scanning Electron microscopy

Strong adhesion of mussels, byssus

Immersion in shallow water (<30m) → more mussel colonization.  
Results in local fibre disorientation and damage.  
Weak points accentuated when mussels removed.  
**Limits possibilities for re-use of mooring lines.**

- 1 - Find a solution to extend the lifetime of the textile rope for the mooring of weatherbuoy.
- 2 - Carry out a similar analysis with a protected rope to avoid detrimental effects of colonisation by mussels.
